AEROSPACE REPORT NO.
TR-92(2935)-17

Long Duration Exposure Facility Experiment M0003 Deintegration/Findings and Impacts

M. J. MESHISHNEK, S. R. GYETVAY and C. H. JAGGERS
Mechanics and Materials Technology Center
Technology Operations

15 December 1992

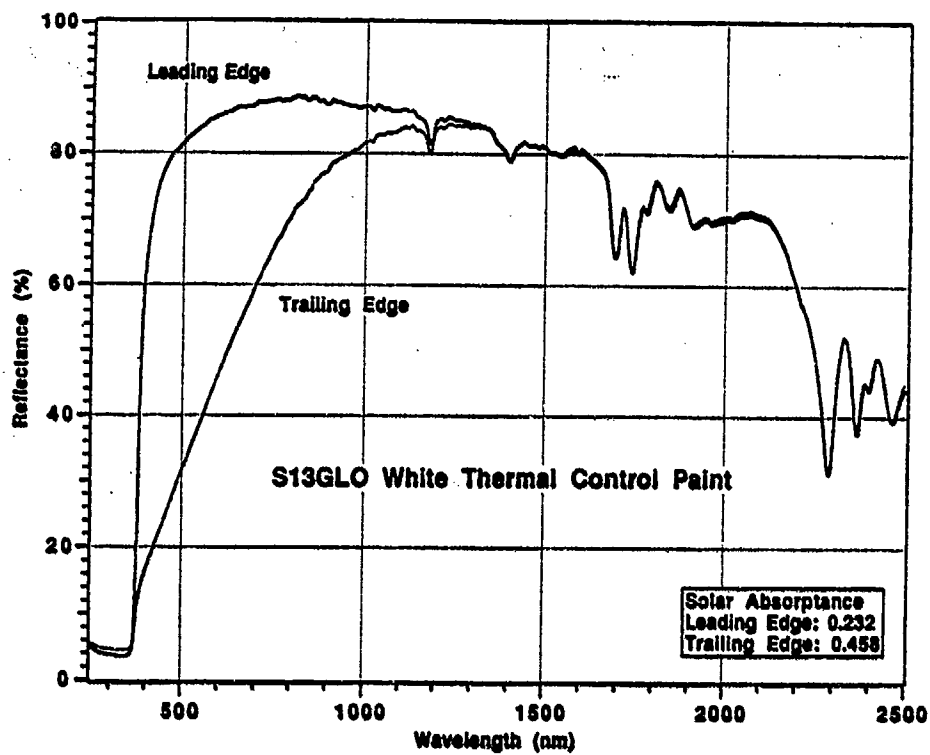
The M0003 signal conditioning units (SCU) sunshields were painted with S13GLO and two each witness test articles were also flown on the D3 and D9 trays. Chemglaze S13GLO is a ZnO pigment encapsulated in K_2SiO_3 dispersed in a methyl silicone binder. Comparison of LE and TE specimens using either the test articles, shown in Figure 31, or specimens from the SCU covers, shown in Figure 32, dramatizes the damage to the TE paints from UV. Reflectance curves of these two samples are given in Figure 33. More important, the roughly 300% increase in α_s from control to TE is not in line with predictions from ground test results (Refs. 2 and 3). These specimens are still under investigation, but microscopy and surface analysis have not indicated detectable erosion of the material. It is believed that the UV-induced color centers formed by oxygen vacancies on the trailing edge are oxidized or annealed on the leading edge by AO. This mechanism is still under investigation. Response of S13GLO to AO and UV is important since this tends to be the paint of choice for many SMC programs because of its ease of application, low cost, low α_e , and flexibility.

The degradation of some paints, coatings, and films was significantly greater than expected. The threefold increase in α_s of S13GLO, the crazing of MgF_2 , and the erosion of Ag/FEP, all point to a need for better correlation of ground and flight test data, and better test methods. The significant number of adhesive failures raises the issue that longer testing is required to evaluate the effects of repeated thermal cycling on adhesive performance.

Figure 33. Reflectance curves for S13GLO
